# Manhole Inspection Summary

Manhole # S33MM\_025MH

Insp Date: **11/28/06 4:02 PM**

**Location** Address: **2001 MARYLAND AVE**

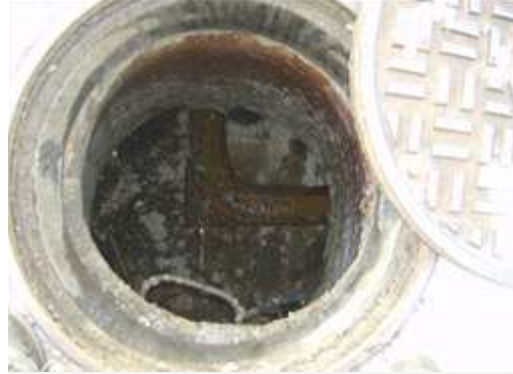
Top View

**Bench** ☒ Exists Material: **Brick** ☐ Parged ☒ **Debris** (not Condition related)

**Channel** Material: **Brick** ☐ Parged ☒ **Debris** (not Condition related)

**Surcharge** ☒ **Evidence Of Surcharge** Depth: **2** (ft.) ☐ Active Surcharge Present

Evidence of surcharge - Bench debris.  
Channel debris.

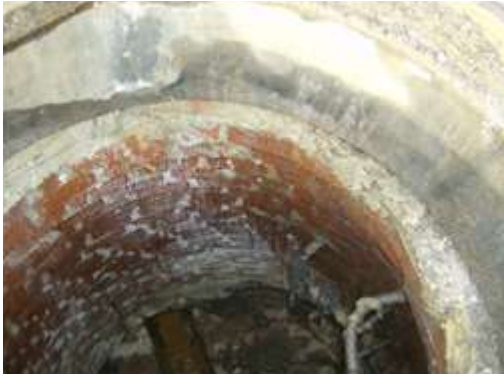
Defect

**Frame** Offset: **0** (in.) Condition: ☐ Sound ☐ Cracked ☒ **Leaks**

Condition: ☐ Sound ☐ Cracked ☐ Root Intrusion ☐ Loose Brick ☒ **Deteriorated**

Infiltration: ☐ None ☒ **Joint** ☐ Cracks ☐ Mortar ☐ Roots ☐ Wall

Infiltration: ☐ None ☐ Joint ☐ Cracks ☐ Mortar ☐ Roots ☒ **Wall**

Frame leaks. Frame offset. Adjustment  
deterioration and infiltration. Barrel  
infiltration.

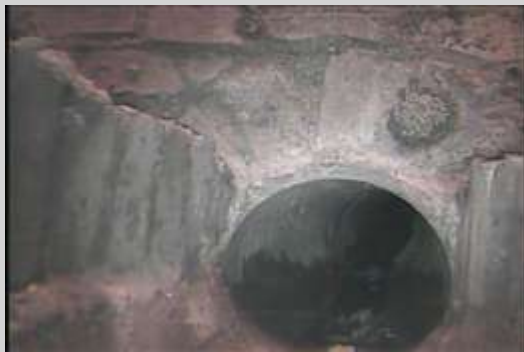
### 8 in. Circular Gravity Sewer Pipe Out @ 12 O'Clock

Pipe Material: **Clay** ☐ Pipe Lined

Invert Depth: **7.81** (ft.) Flow Characteristics: **None**

Deposits: ☒ None ☐ Mud ☐ Sludge ☐ Debris ☐ Grease

Infiltration: **None** Pipe Seal Cond: **Unknown**

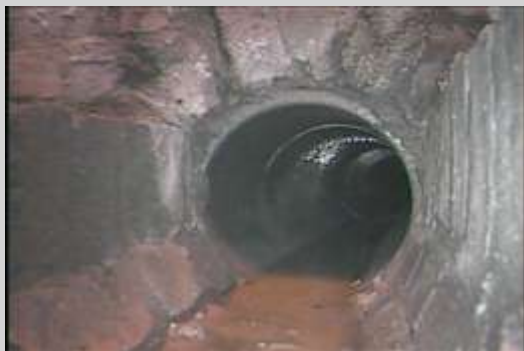
### 8 in. Circular Gravity Sewer Pipe In @ 3 O'Clock

Pipe Material: **Clay** ☐ Pipe Lined

Invert Depth: **7.61** (ft.) Flow Characteristics: **None**

Deposits: ☒ None ☐ Mud ☐ Sludge ☐ Debris ☐ Grease

Infiltration: **None** Pipe Seal Cond: **Unknown**
